USARTL-TR-78-48

**ICING TESTS OF A UH-1H HELICOPTER WITH AN
ELECTROTHERMAL ICE PROTECTION SYSTEM UNDER
SIMULATED AND NATURAL ICING CONDITIONS**

**R. H. Cotton
LOCKHEED-CALIFORNIA CO.
P.O. Box 551
Burbank, Calif. 91520**

Final Report for Period 31 January 1978 - 31 March 1978

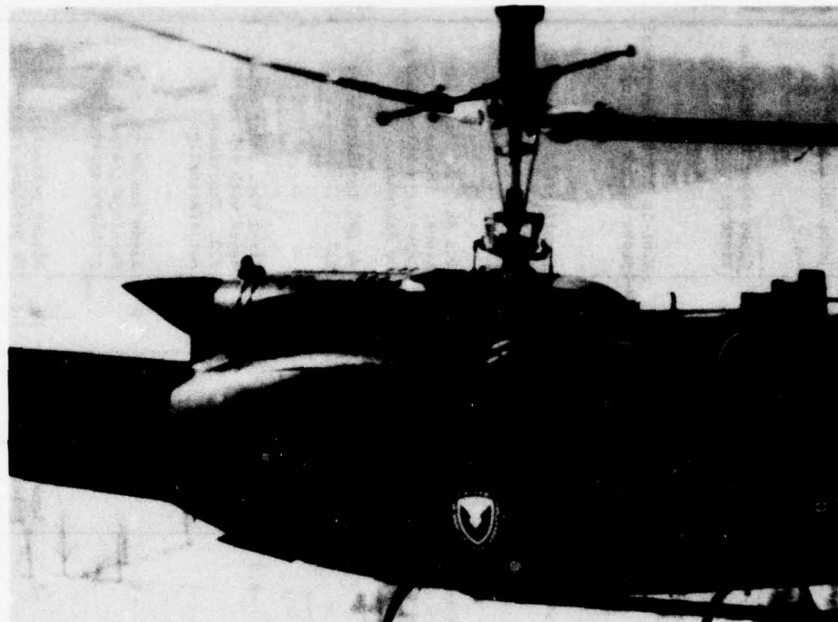
Figure 9 shows the test aircraft as photographed from the chase aircraft following 37 minutes in icing at -12.5°C at 7300 feet for two blade deicing cycles and 14 minutes after exiting the icing condition. Even though the OAT was still below 0°C , no significant icing on the test aircraft is apparent except on the engine air inlet side screen. Figure 26, another photo taken on the same flight, shows ice on the leading edges of the ice detector pylons and the UHF/VHF antenna. There was also some ice on the RH stabilizer leading edge. This illustrates the difficulty in a quantitative assessment of natural icing results especially with respect to blade deicing, the primary objective.

Figure 9. Test Aircraft Following Exit From Natural Icing Cloud on Flight 180, Showing Icing on Engine Air Inlet R.H. Screen.

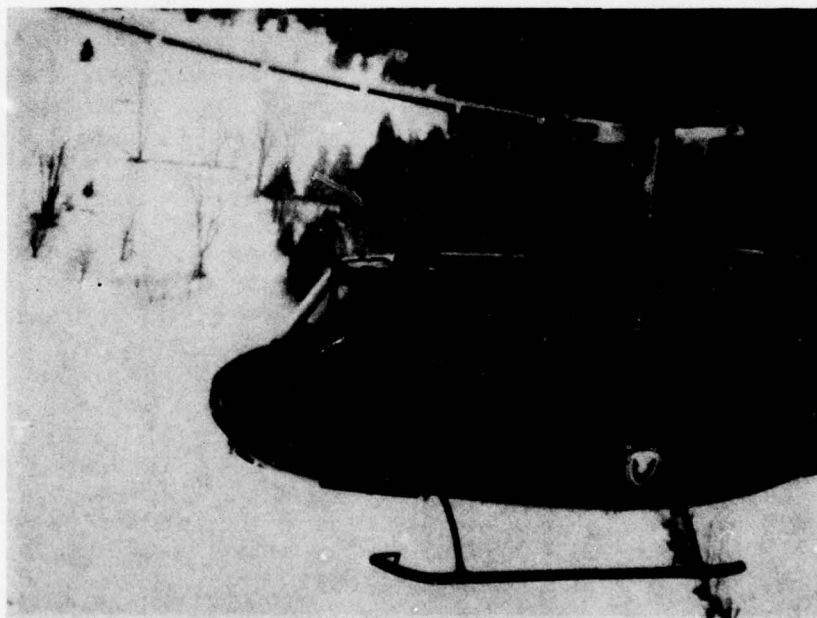
Figure 26. In-Flight Photo Following Natural Icing Cloud Exit (note ice on the UHF antenna and the ice detector pylon).

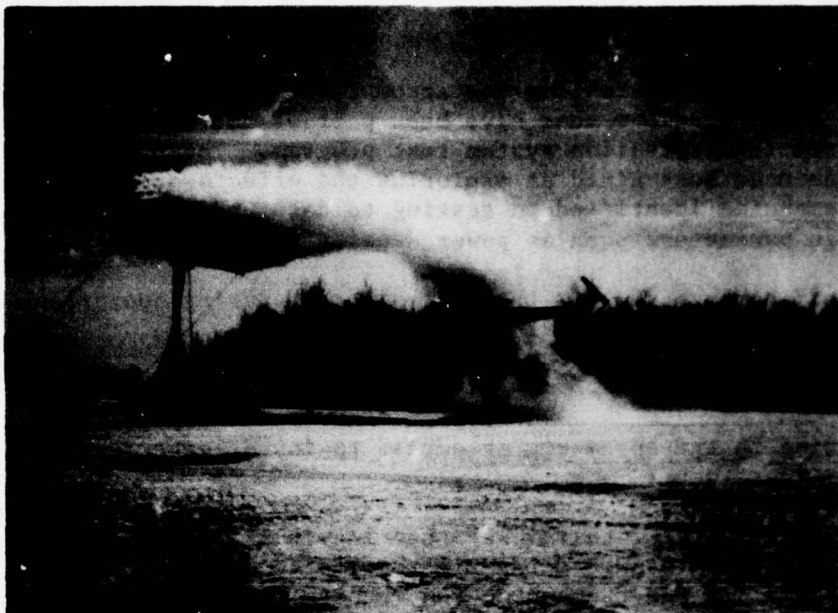
Figure 27. UH-1H Operating in the Spray Rig With 0.7 g/m^3 Cloud at -7.0°C with 9-10 mph East Wind (heavy inlet screen icing was experienced).

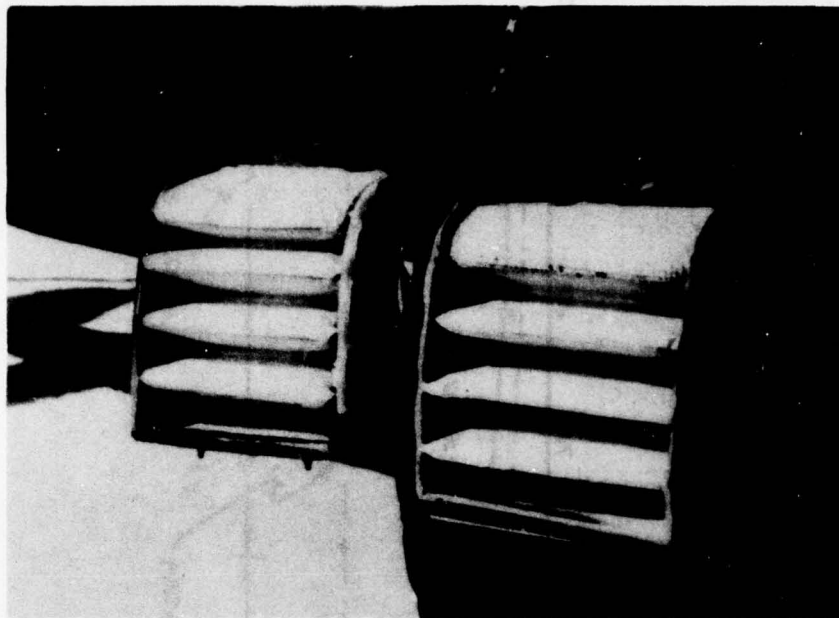
Figure 31. Right and Left Side Engine Air Inlet Screen Icing that Produced 10 inches $H_2O\Delta P$ - Spray Rig Cloud 0.7 g/m^3 at -7°C .

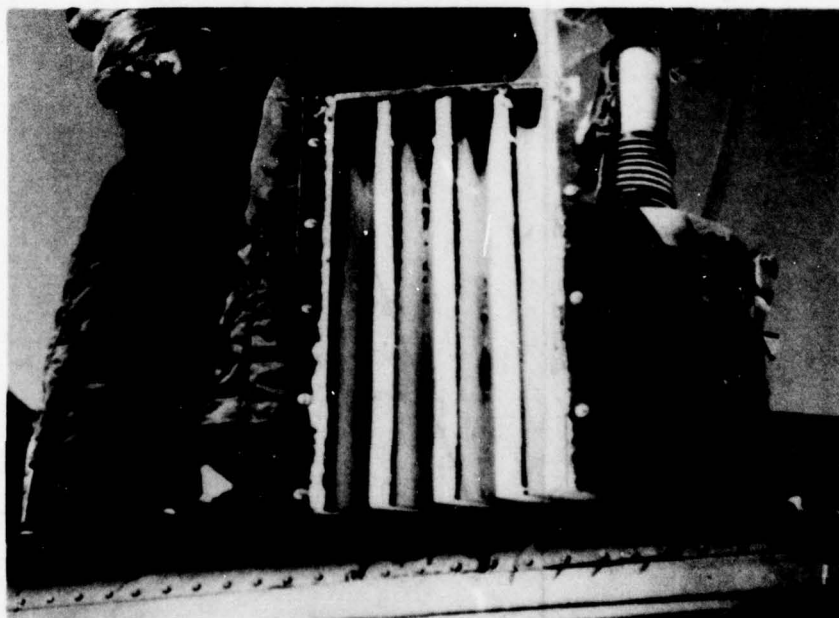
Figure 32. Top Engine Air Inlet Screen Icing from Same Spray Rig Run (30 minutes) as Above.

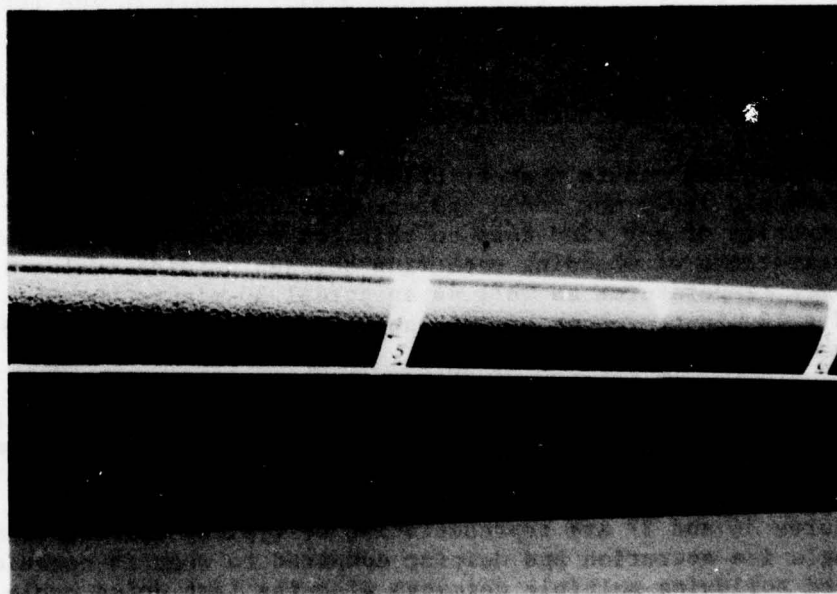
Figure 35. Close-Up of Blade Ice Density and Texture at 0.55 g/m^3 at -11.8°C (note the double horn leading edge ice formation shape).
